DUO HOME INSPECTION

Property Inspection Report

Client(s): **Maira De La Torre**
Property address: **3844 Silver Tree Court**
Rialto CA.
Inspection date: **Tuesday, February 09, 2016**

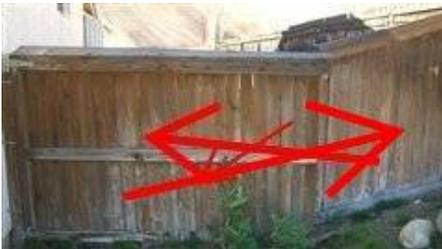
Photo 4-1

Fence gate on right front is deteriorated and falling down. Recommend licensed contractor to repair

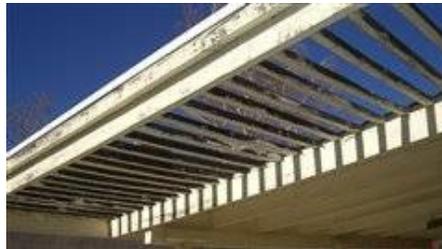
Photo 4-2

Patio cover in back yard is deteriorated and paint is peeling. There is many areas of dry rot . Recommend licensed contractor to repair.

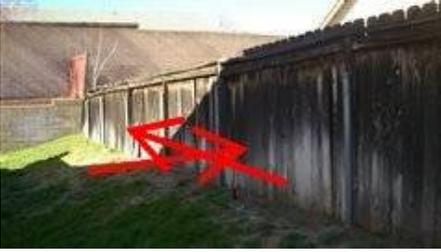
**Photo 4-3**

Fence in back yard is deteriorated on both sides, many loose slates and supports. Recommend licensed contractor to repair.

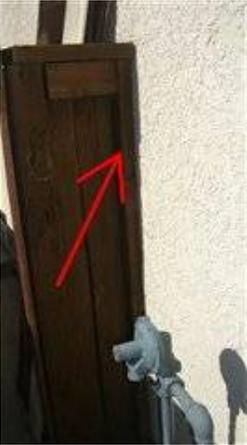
**Photo 5-1**

Gate support on left side of house is deteriorated and pulling away from house. Recommend licensed contractor to repair.

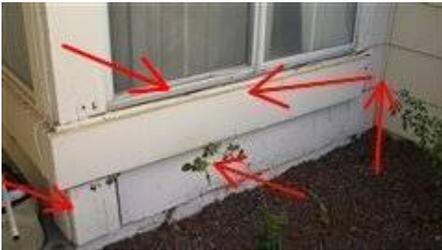
Photo 9-1
Window (front) frame and casing is dry rotted and house wall trim is deteriorated. Recommend licensed contractor to repair.

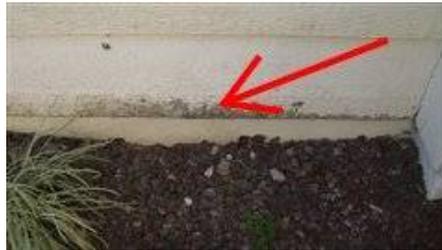
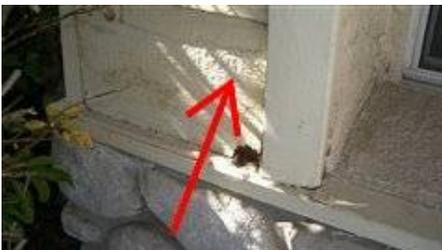
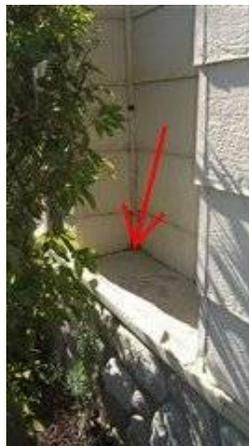
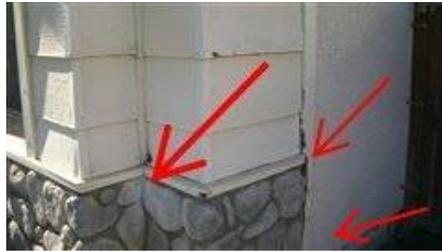
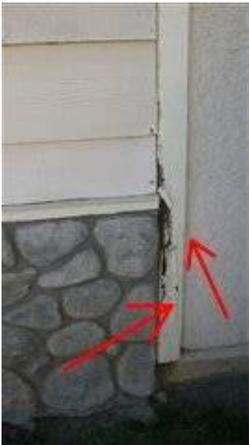
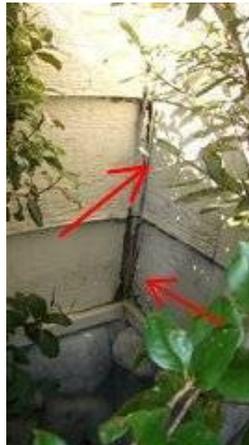
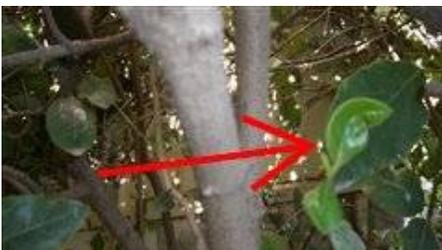
Photo 9-2
House covering around entire house is deteriorated at bottom areas. Recommend licensed contractor to repair.

Photo 9-3
House covering around entire house is deteriorated at bottom areas. Recommend licensed contractor to repair.

Photo 9-4
House covering around entire house is deteriorated at bottom areas. Recommend licensed contractor to repair.

Photo 9-6
House covering around entire house is deteriorated at bottom areas. Recommend licensed contractor to repair.

Photo 9-7
House covering around entire house is deteriorated at bottom areas. Recommend licensed contractor to repair.

Photo 9-8
House covering around entire house is deteriorated at bottom areas. Recommend licensed contractor to repair.

Photo 9-9
House covering around entire house is deteriorated at bottom areas. Recommend licensed contractor to repair.

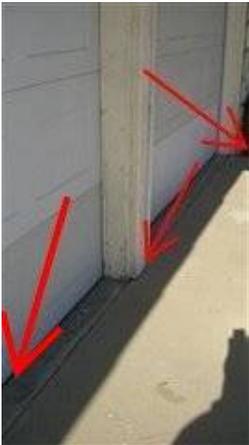
Photo 9-5
Garage door trim is deteriorated and paint is peeling at bottom of both doors. Recommend licensed contractor to repair.

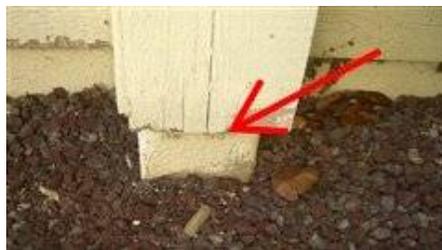
Photo 9-10
Front cover area support post in front of entrance is dry rotted at bottom. Recommend licensed contractor to repair.

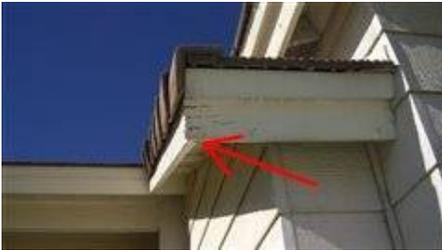
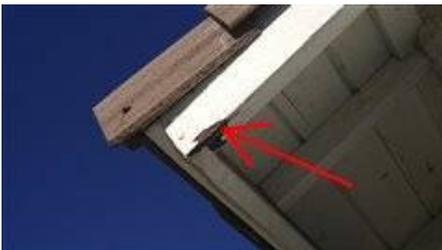
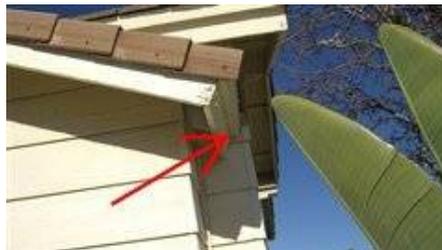
Photo 11-1
Roof (fascia) trim is deteriorated on front of house in many places. Paint is peeling as well. Recommend licensed contractor to repair.

Photo 11-3
Roof (fascia) trim is deteriorated on front of house in many places. Paint is peeling as well. Recommend licensed contractor to repair.

Photo 11-4
Roof (fascia) trim is deteriorated on front of house in many places. Paint is peeling as well. Recommend licensed contractor to repair.

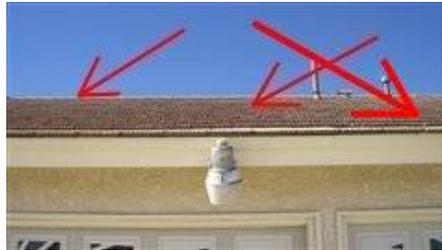
One or more metal roof tiles were damaged. Leaks may occur as a result. Recommend that a qualified person repair as necessary.

Found many areas had chunks of tile off on corners and flat areas.

Photo 11-2
Roof area on entire roof has chunks of roofing tile material missing . Recommend licensed roofing contractor repairs.

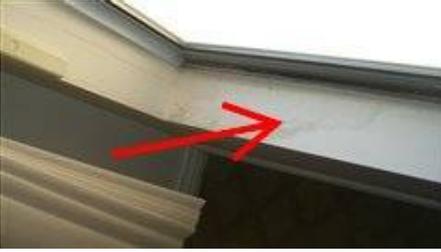
**Photo 11-5**

Roof (fascia) trim is deteriorated on front of house in many places. Paint is peeling as well. Recommend licensed contractor to repair.

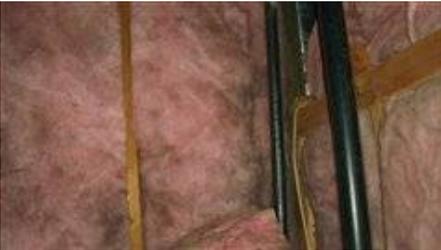
**Photo 12-1**

Insulation in attic area is normal.
(estimated rating of r30 plus.)

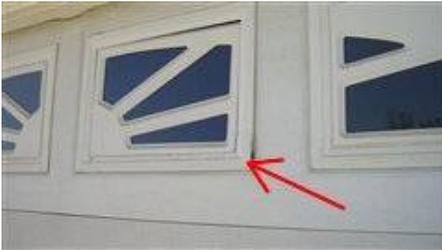
Photo 16-1

Garage door is damaged at right window on main door. Recommend licensed contractor to repair.

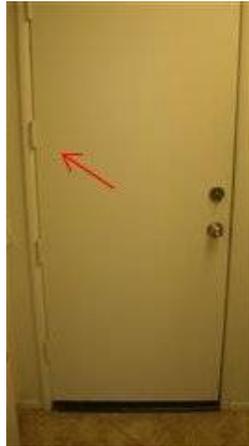
Photo 16-2

Fire door to garage is damaged at hinges and will not auto return. The door has been modified with a nonstandard return mechanism. Also the weatherstripping is deteriorated. This is a safety hazard and needs immediate attention. Recommend licensed contractor to repair.

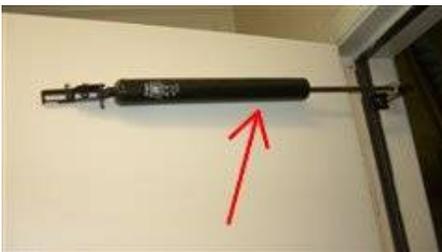
Photo 16-3

Fire door to garage is damaged at hinges and will not auto return. The door has been modified with a nonstandard return mechanism. Also the weatherstripping is deteriorated. This is a safety hazard and needs immediate attention. Recommend licensed contractor to repair.

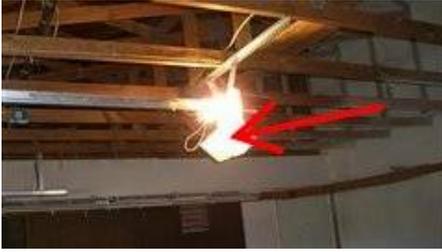
**Photo 17-1**

Garage door opener on main door is inoperable. Recommend licensed contractor to repair.

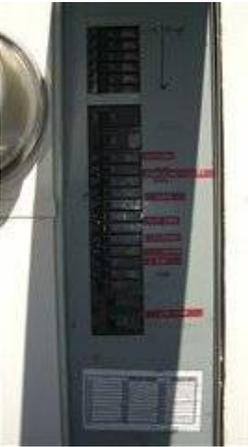
Photo 21-1
Electrical panel is located on left front side of garage.

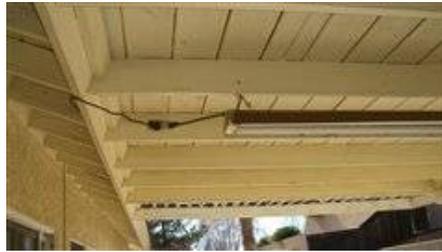
Photo 21-2
Lighting wiring on back porch cover is substandard. Recommend licensed electrician to repair.

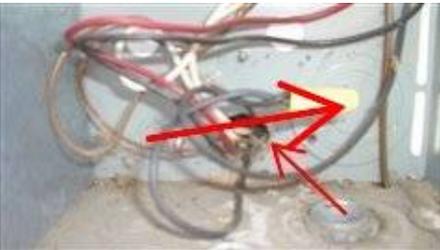
Photo 21-3
Wiring in electrical panel box is substandard and is missing insulators at bottom of panel. Recommend licensed electrician to repair.

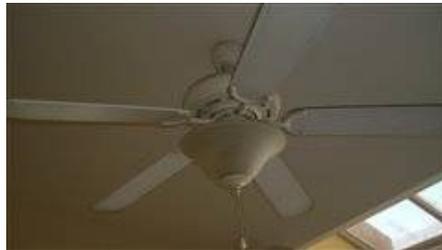
Photo 21-4
Ceiling fans in many rooms are inoperable. Recommend licensed contractor to repair.

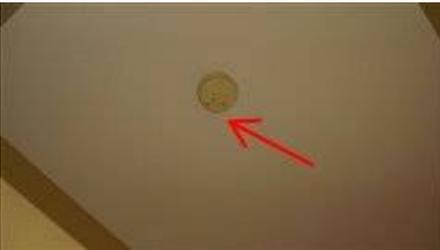
Photo 21-5
Smoke and carbon dioxide detectors are missing and inoperable. This is a safety hazard and needs immediate attention. Recommend licensed contractor to repair.

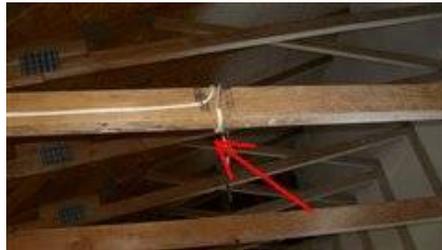
Photo 21-6
Wiring in garage ceiling area is substandard and open. This is a safety hazard and needs immediate attention. Recommend licensed electrical contractor to repair.

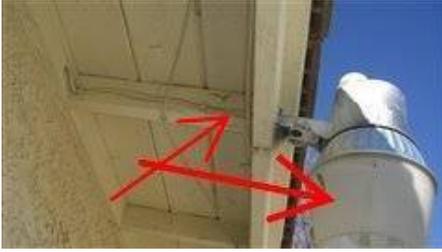
**Photo 22-1**

Light assembly on garage fascia is damaged and wiring is substandard. Recommend licensed electrical contractor to repair.

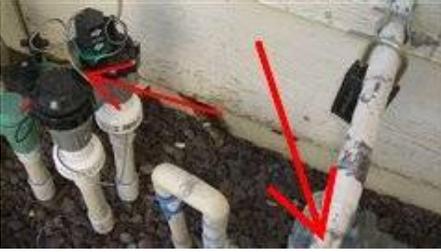
**Photo 24-1**

Yard irrigation valving wiring is damaged and system is inoperable. Water , main diverter valve is inoperable (120psi) water pressure going into house. Recommend licensed contractor to repair.

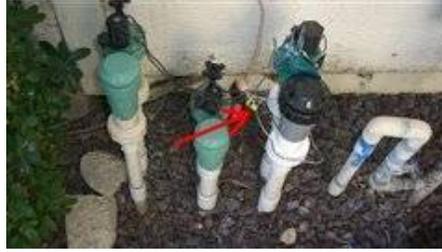
**Photo 24-2**

Yard irrigation system valve wiring is damaged and system is inoperable. Recommend licensed contractor to repair.

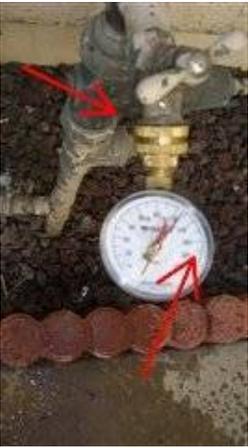
**Photo 25-1**

The water supply pressure was greater than 80 pounds per square inch (PSI). Pressures above 80 PSI may void warranties for some appliances such as water heaters or washing machines. Flexible supply lines to washing machines are likely to burst with higher pressures. 40-80 PSI is considered the normal range for water pressure in a home, and most plumbers recommend 50-60 PSI. Typically, the pressure cannot be regulated at the water meter. Recommend that a qualified plumber evaluate and make modifications to reduce the pressure to below 80 PSI. Installing a pressure reducing valve on the main service pipe is a common solution to this problem. If one exists, then it should be adjusted, repaired or replaced as necessary to maintain lower pressures. Note that installing a pressure reducing valve creates a "closed system," which may require installing an expansion tank at the water heater if one is not already installed.

Water main diverter valve is inoperable (high pressure 120 psi) entering house. Recommend licensed plumber to repair.

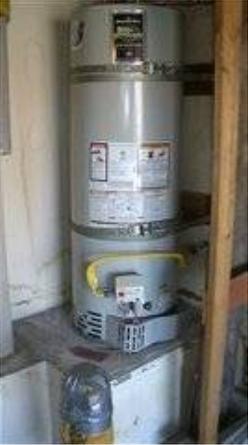
Photo 26-1

Water heater is located in the garage.

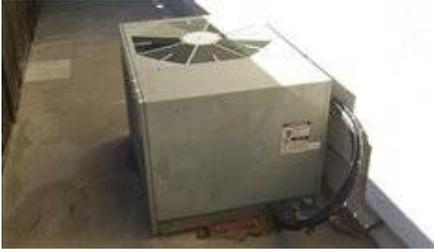
**Photo 28-1**

Insulation on the heat pump or air conditioning condensing unit's refrigerant lines was deteriorated or missing in some areas. This may result in reduced efficiency and increased energy costs. Recommend that a qualified person replace or install insulation as necessary.

HVAC compressor/condenser unit needs servicing and cleaning. The refrigerant line thermo wrapping is missing. Recommend licensed HVAC contractor to repair.

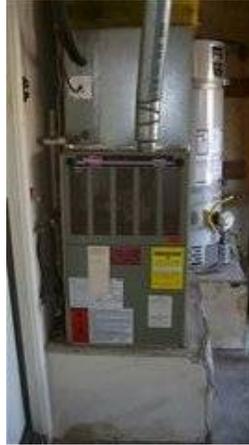
**Photo 28-2**

HVAC furnace system is located in the garage, system needs a serviceing. Recommend licensed HVAC contractor to repair.

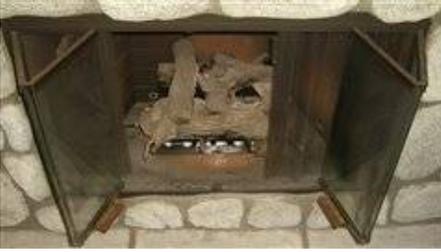
**Photo 31-1**

Fireplace is gas powered and was inoperable. The fireplace also needs cleaning. Recommend licensed chimney sweep to repair.

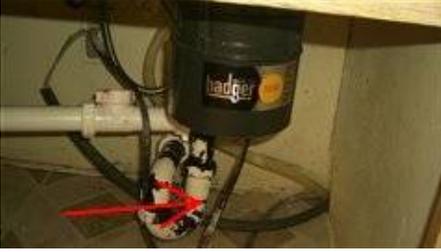
**Photo 41-1**

Kitchen sink plumbing is leaking. Recommend licensed plumbing contractor to repair.

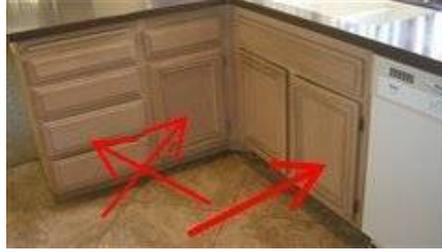
**Photo 41-2**

Kitchen cabinets are deteriorated and needs cleaning. Many doors are loose and drawers are hard to open and close. Recommend licensed contractor to repair.

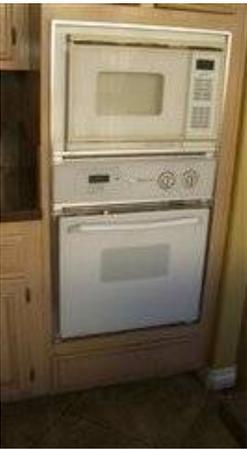
**Photo 41-3**

Kitchen appliance all are inoperable and at end of useful life. Recommend licensed contractor to repair.

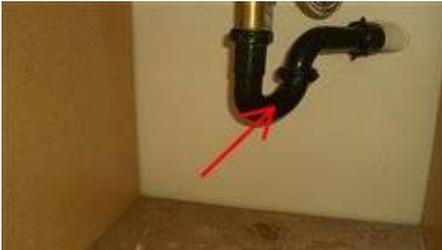
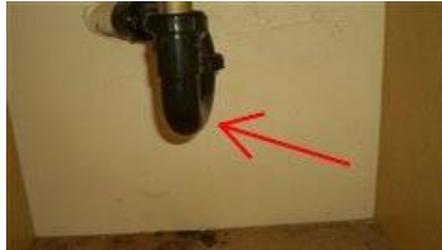
Photo 53-1
Master bathroom sink plumbing is leaking. Recommend licensed plumbing contractor to repair.

Photo 53-2
Master bathroom sink plumbing is leaking. Recommend licensed plumbing contractor to repair.

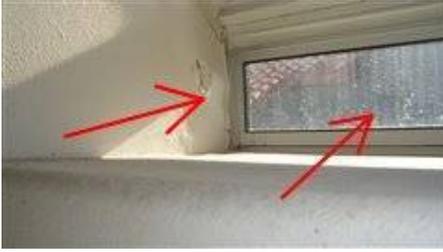
**Photo 53-3**

Walls in master bathroom by tub area are deteriorated and have sever water damage, high moister content was found by inspector and gauge assembly. Recommend licensed contractor to repair. All windows in master bathroom are deteriorated and leaking.

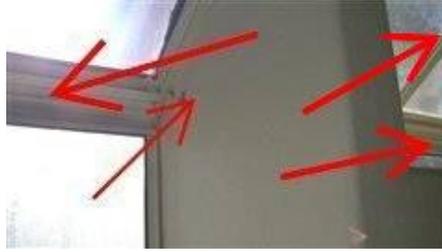
**Photo 53-4**

Walls in master bathroom by tub area are deteriorated and have sever water damage, high moister content was found by inspector and gauge assembly. Recommend licensed contractor to repair. All master bathroom windows are deteriorated and leaking.

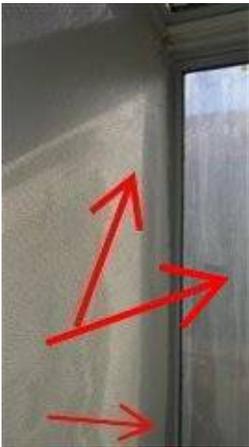
**Photo 53-5**

Walls in master bathroom by tub area are deteriorated and have sever water damage, high moister content was found by inspector and gauge assembly. Recommend licensed contractor to repair.

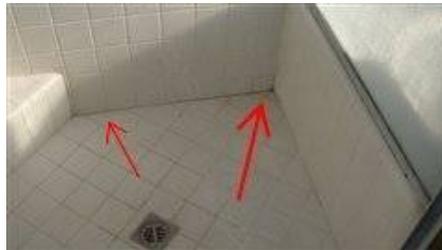
**Photo 53-6**

Master bathroom shower floor area needs re-caulking and cleaned. Recommend licensed contractor to repair.

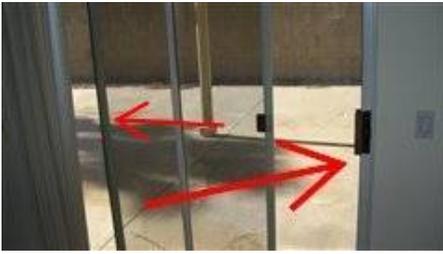
Photo 66-1
Sliding glass doors (all) are inoperable and fogging in glass. Recommend licensed contractor to repair.

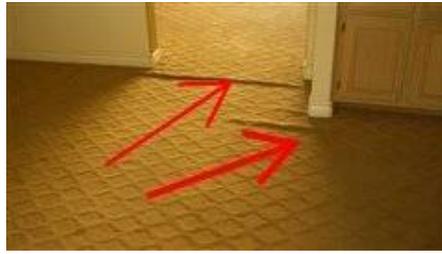
Photo 66-2
Carpeting throughout house is damaged and deteriorated and many areas are a trip hazard. Recommend licensed contractor to repair.

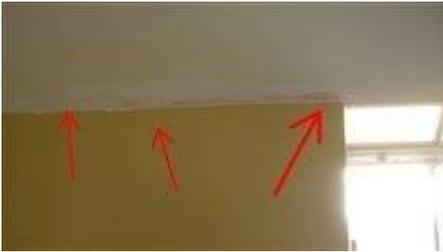
Photo 66-3
Ceiling in den area (east wall side) has water stains which looks current. Recommend licensed contractor to repair.

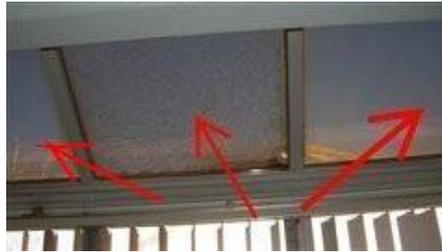
Photo 66-4
Windows in den and kitchen area are deteriorated and leaking, glass is fogging and loose and broken in many areas. Recommend licensed contractor to repair.

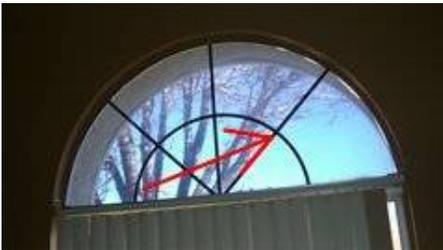
Photo 66-5
Front house arch windows are broken in many areas. Recommend licensed contractor to repair.

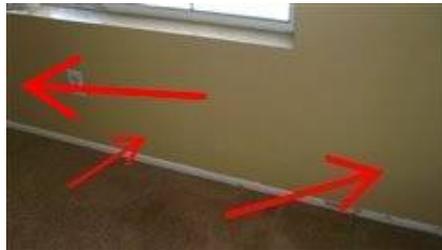
Photo 66-6
Front bottom wall , below main front window has severe water damage. Recommend licensed contractor to repair.

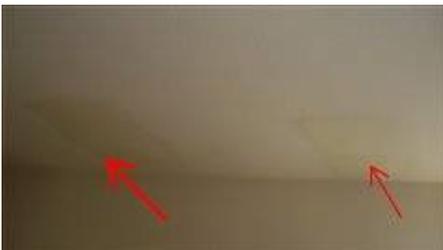
Photo 66-7
Ceiling on west wall side in master bedroom has been repaired and needs repainting. Recommend licensed contractor to repair.
